Superior Carbon Products, S.A.

## *Patina appearance on electrical rotary commutator machines*

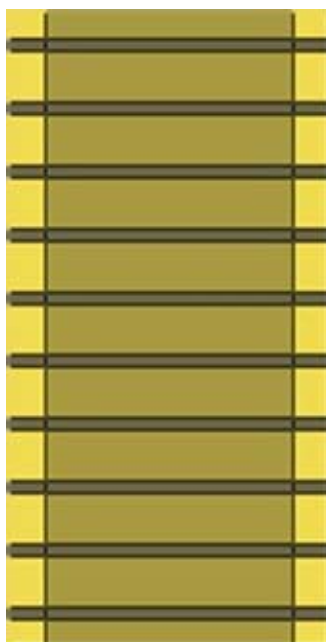
### **1. GOOD APPEARANCE**

#### *LIGHT BROWN PATINA*

The uniform patina color indicates a good machine and carbon-brush operating. The color of the patina can be attributed mainly to its thickness and whenever it is uniform it is completely acceptable.

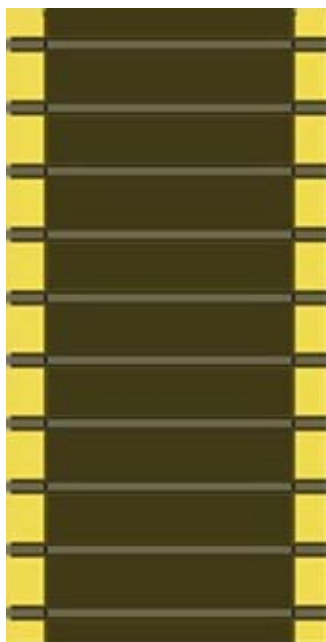
### **2. GOOD APPEARANCE**

#### *DARK BROWN PATINA*

Another commutator example of excellent operating conditions. Patina is much darker than above in figure 1, but the really important fact is the color's uniformity.

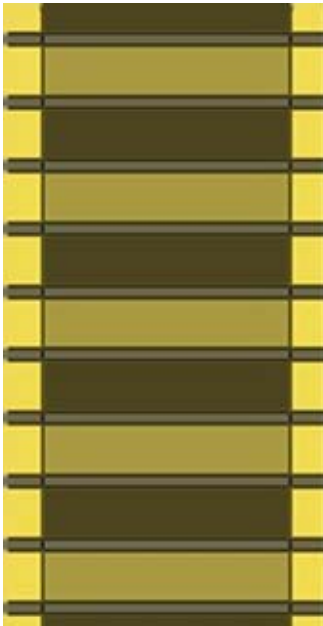
### 3. ACCEPTABLE APPEARANCE

#### *ALTERNATING LIGHT -DARK BROWN PATINA*

This is not as good status as figures 1 and 2, but from our experience we know, that there are lots of machines that operate satisfactorily during long time in spite of having this commutator appearance. Sometimes, commutator segments are alternatively dark and light, sometimes there is only one dark segment each 3 or 4 segments. This appearance is attributed to winding aspects.

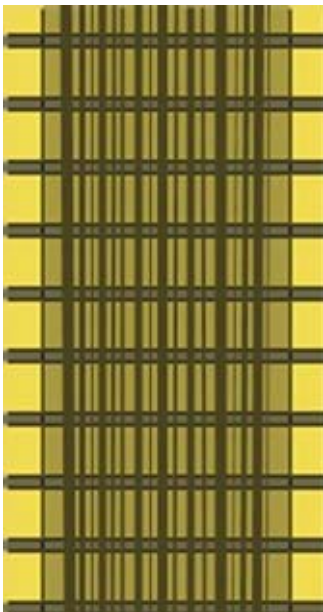
### 4. INADECUATE APPEARANCE

#### *GROOVED PATINA WITHOUT COMMUTATOR SURFACE WEAR*

This is frequently attributed to low load operations, excessive brush quantities, or an inadequate brush grade for the machine's application. Also the environmental conditions and the atmosphere may influence here.

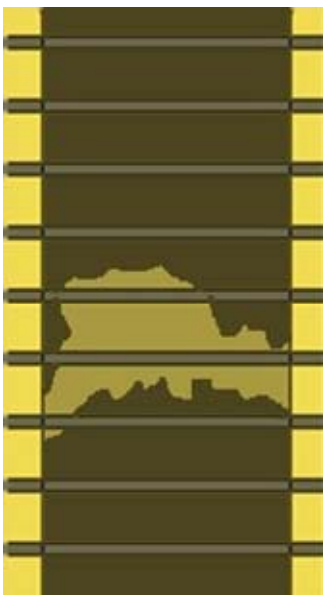
### 5. INADECUATE APPEARANCE

#### *UNEVEN PATINA*

Different color, dark-light tone or forms of spot formation. This is caused due to highly clean operating conditions or due to commutators physical status.

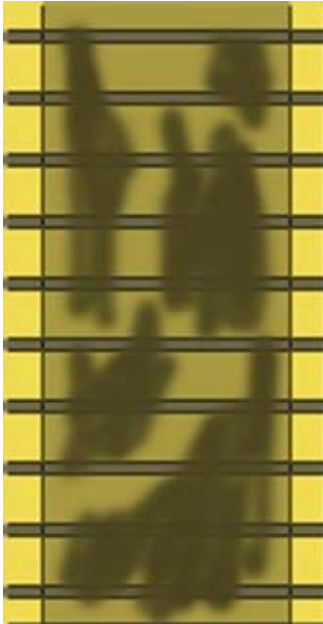
## 6. INADECUATE APPEARANCE

### *PATINA WITH DARK AREAS*

These areas may be regularly disseminated or insulated. Causes could be:

- Commutator out of roundness or oval-shaped
- Vibrations or mechanical facility deficiencies, bearings, coupling, etc.

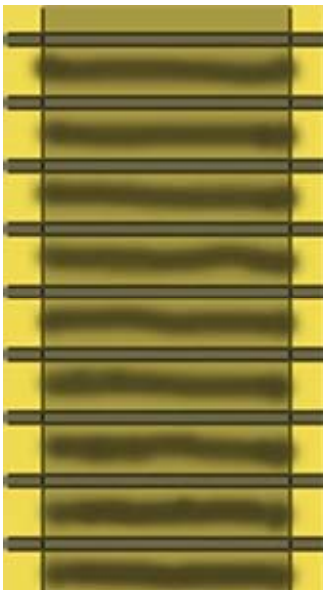
## 7. INADECUATE APPEARANCE

### *DEFFECTIVE MACHINING OF COMMUTATOR SURFACE*

Protruding mica of commutator segments so that brushes only have contact on the middle of the segment.

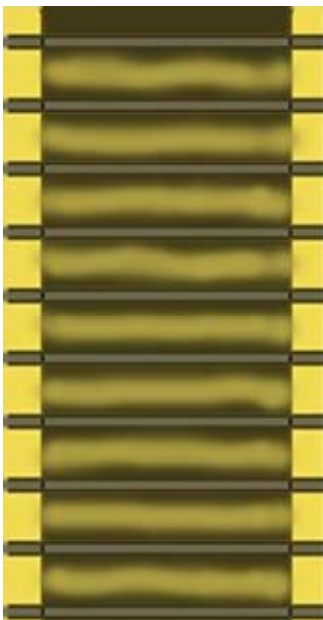
## 8. INADECUATE APPEARANCE

### *DEFFECTIVE MACHINING OF COMMUTATOR SURFACE*

Segments are decreased on the middle, so that brushes only have contact on the borders. This figure and the aforementioned both need a more carefully maintenance.

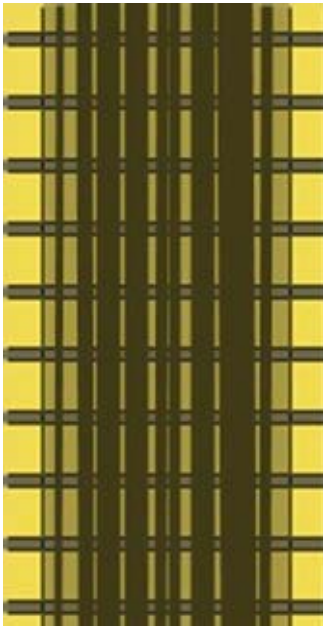
### 9. INADEQUATE APPEARANCE

#### *GROOVED PATINA WITH COMMUTATOR SURFACE WEAR*

This is a more advanced stage of figure 4. The adequate carbon brush grade, machine's operating service and environmental conditions have to be checked. Also maintenance has to be improved, it should have required earlier actuation before reaching this appearance stage .

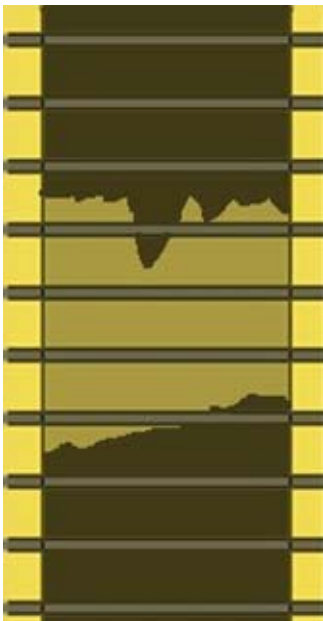
### 10. INADEQUATE APPEARANCE

#### *BLACKENING OF COMMUTATOR AT BOTH POLE PITCHES*

This can be attributed to a winding failure or a defective coil.

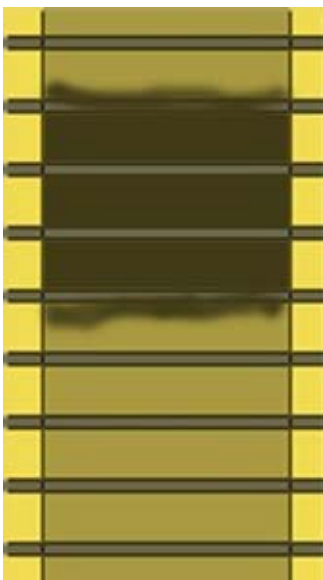
### 11. INADEQUATE APPEARANCE

#### *CARBON BRUSH FOOTPRINTS*

Due to long storage of the machine with already assembled brushes. Also due to a long starting of the stopped machine.

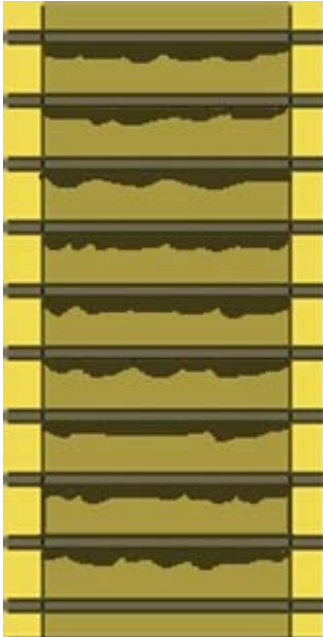
## 12. INADECUATE APPEARANCE

### *BURN MARKS ON PROTRUDING MICA SEGMENT EDGES*

Here it is shown a case with all segments protruding micas, but this same appearance may occur at only one segment. Similar conditions can be found due to one protruding or decreased segment.

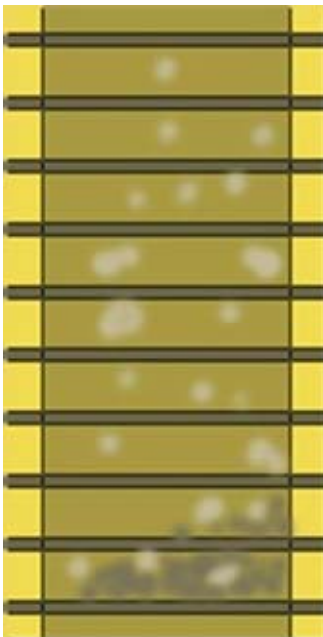
## 13. INADECUATE APPEARANCE

### *SMALL BRIGHT DOTS*

Generally it occurs on machines with overload and low carbon brush pressure. Due to the brush sparking small bright disseminated dots appear. If proper measures aren't implemented, grooves will appear on the commutator surface.
